## Summary of TOMAC Arbitration

### “STAR ISLAND”

Sale of ship – NIPPONSALE 1993 – Construction of MOA Clause 5 - Whether alleged defect was an ‘average damage affecting her present class’

Tokyo, 3 December 2010

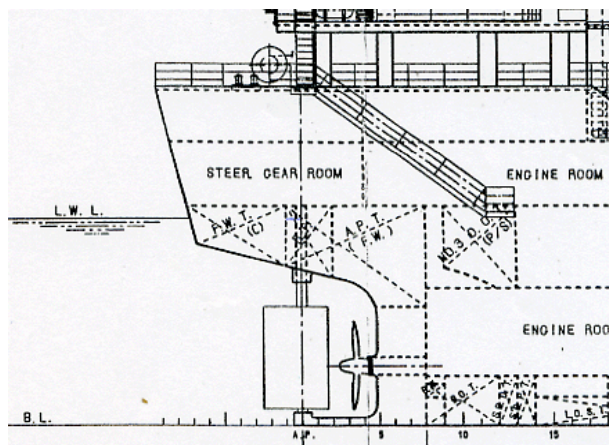
Diagram 1: profile of the stern section of the Vessel

- vi) Claimants' Exhibit 24 (General Arrangement Plan) shows that the Vessel was installed by Type B rudder as classified by NK in reference to Respondents' Exhibit 13;

It follows that the allowance for clearance at pintle bushing is, depending upon diameter of the pintle, is not to exceed 7.5 *mm* in this case.

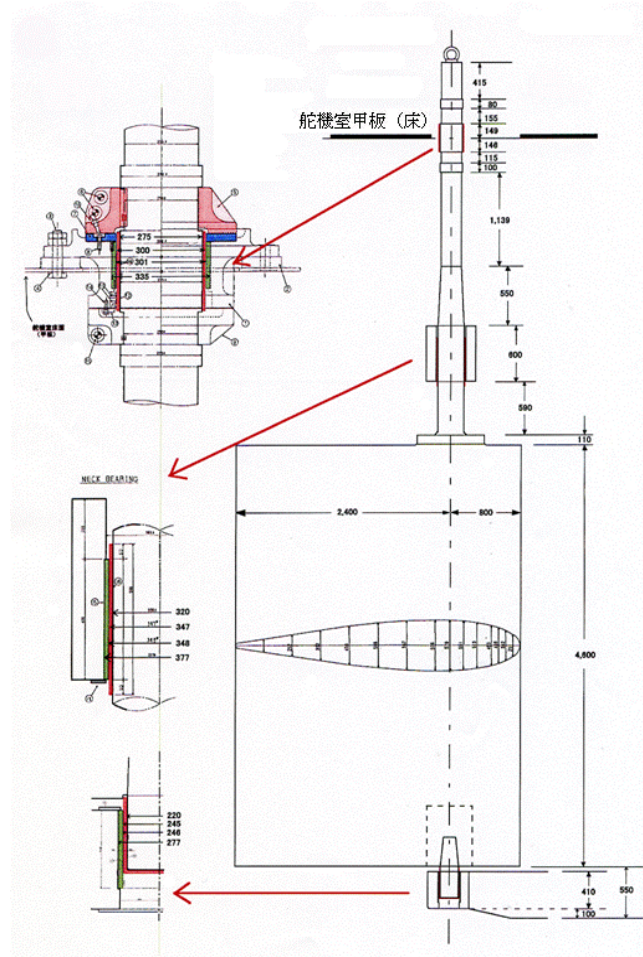
Diagram 3: Rudder Construction of the Vessel

- xi) For the reasons above, the Tribunal reaches a conclusion that there was no damage to carrier bearing affecting her present class at the time of the delivery even if there existed a clearance of 4.80 *mm* at the carrier bearing.

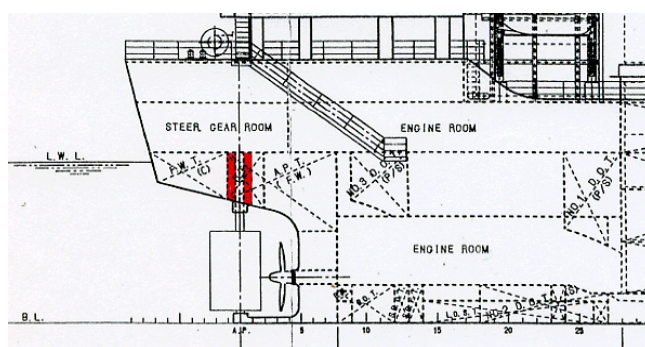
Diagram 4: Position of Rudder Trunk and its form

- ii) “rudder trunks which are open to the sea”: From Claimants’ Exhibit 30 (MO disc containing still photographs taken on the occasion of the Hiroshima District Court’s preservation of evidence proceedings) and Claimants’ Exhibit 24 (General Arrangement Plan of the Vessel) it is understood that on board the Vessel a rudder trunk of which the dimension was 120 *cm* fore-and-aft, 140 *cm* port-and-starboard, approx. 200 *cm* high was fitted beneath the rudder carrier separated by 2<sup>nd</sup> deck steel plate in between and the rudder stock penetrated vertically almost in its middle. The position of the rudder trunk as recognized by the Tribunal is indicated in red in the diagram shown hereunder;

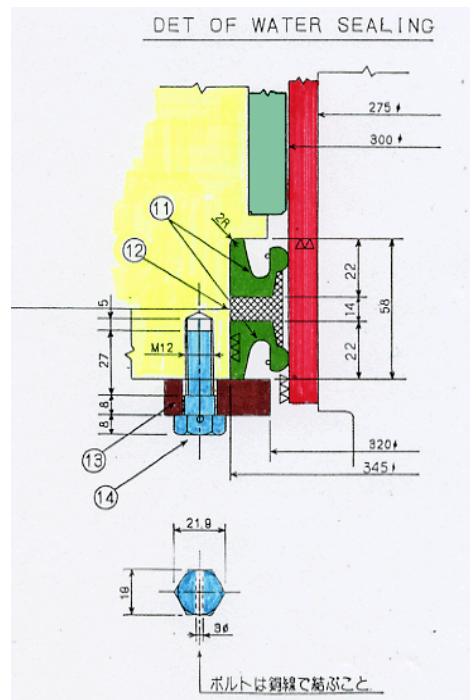
Diagram 6: Details of water sealing

On this diagram the part ⑪ colored in blue is the OIL SEAL of which the component is designated by Claimants' Exhibit 35 to be of Nippon Oil Seal K.K.

- xii) Diagram 6 above shows ⑪OIL SEAL having 2 rings in contact with the sleeve on the rudder stock, of which the component is designated by Claimants' Exhibit 35 to be MG Type Nippon Oil Seal K.K. The material property of the OIL SEAL is not known to the Tribunal, but from its form and similarity to widely

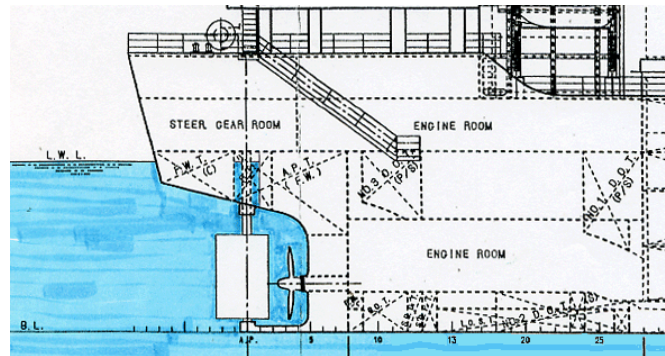
Diagram 7: load water line (even keel) and the surface of water in the rudder trunk

- c) On assumption that the Vessel is fully loaded and even keel, the surface of water in the rudder trunk is about  $50 \text{ cm}$  below the 2<sup>nd</sup> deck level (floor of the steering gear room) as shown in Diagram 7 hereunder;

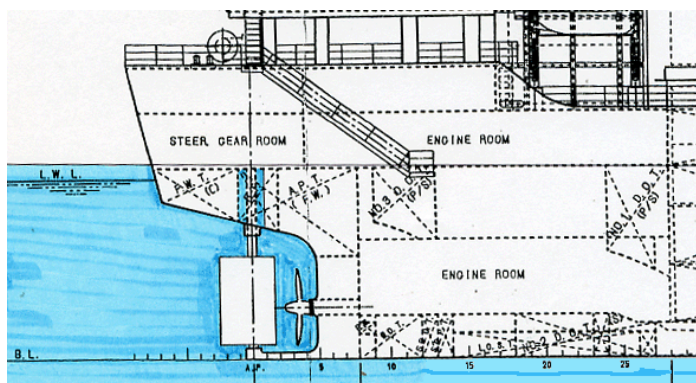
Diagram 8: load water line (trim by the stern), surface of water in the rudder trunk and level of steering gear room

- d) On assumption that the Vessel is fully loaded with the trim by the stern (stern draught being  $75 \text{ cm}$  greater than that of even keel, as is normally the case of a vessel such as this), the surface of water in the rudder trunk reaches the ceiling (lower side of the 2<sup>nd</sup> deck plate) of the rudder trunk. That is to say, the level of the floor of the steering gear room in the vicinity of the rudder trunk is lower than the sea-water level outside by about  $20 \text{ cm}$  at aft of the steering gear room and about  $15 \text{ cm}$  at fore of the steering gear room. It follows that if the water tightness between the rudder trunk and the steering gear room is lost, sea-water enters, with the water-head-pressure of about  $20 \text{ cm}$ , the steering gear room, which is flooded with sea-water of which the depth being about  $20 \text{ cm}$  at aft and about  $15 \text{ cm}$  at fore. This condition is indicated by Diagram 8 hereunder;

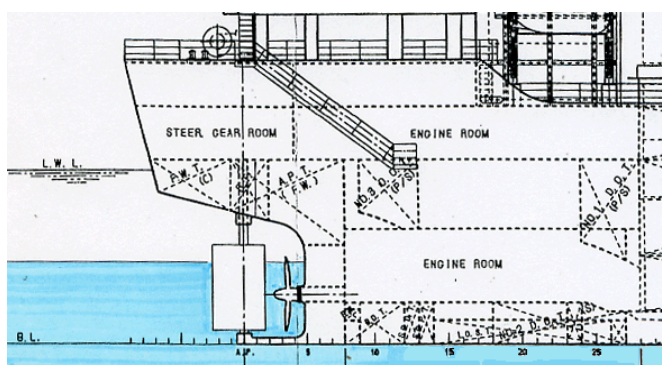
Diagram 9: rudder trunk in ballast condition

- e) When the Vessel is in ballast condition, the rudder trunk is filled up with air alone since water in the rudder trunk, if any, drops through interstices of the neck bearing, as described hereinabove, onto the sea surface. This condition is indicated by Diagram 9 hereunder;

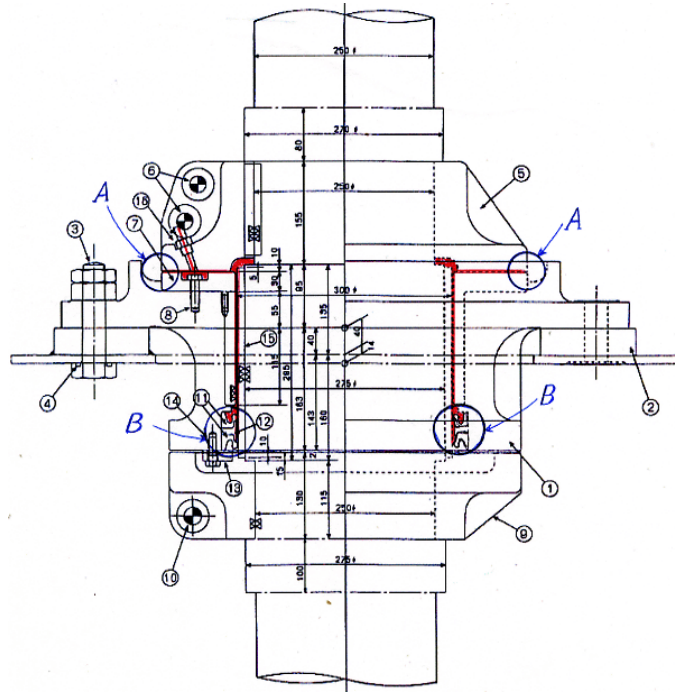
Diagram 10: semi-closed space for grease lubrication

On this diagram, *A* represents the location where old black-stained grease is extruded peripherally, at the final stage of the grease-up operation, from the rubbing surface between the bearing disc and the carrier as pressure is applied by fresh amber/semitransparent grease injected through the grease nipple which is numbered ⑯. On this diagram, *B* represents the location where old black-stained grease is extruded down, at the final stage of the grease-up operation, through interstice between 2 seal rings and sleeve of the rudder stock as pressure is applied from above by fresh amber/semitransparent grease which has come down between bush and sleeve on the rudder stock.

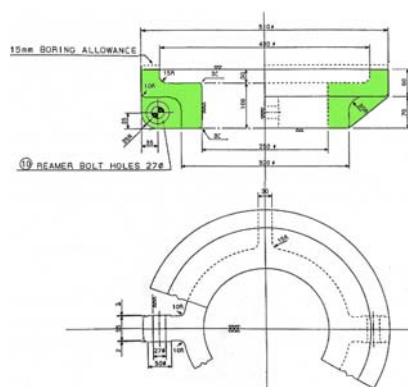
Diagram 13: Details of jumping stopper

xvi) With respect to the Claimants' assertion that presence of rust on jumping stopper and bearing disc (Claimants' Exhibits 30 and 18) suggests that the water tightness was lost there and it is therefore highly likely that sea-water entered the steering gear room from the rudder trunk and lubricant leaked out of the Vessel, the Tribunal finds as follows: A Jumping Stopper is located at the uppermost in the rudder trunk and is exposed to water splash or is completely submerged in water depending on draught and trim, as stated above. Therefore, contact with sea-water was assumed from the time of construction. Claimants' Exhibit 35 indicates that the material property of the jumping stopper is SC42 (a type of cast steel). The jumping stopper takes the form of a deep dish of which the thickness is about 40 *mm*. Thus rust, if any, over the jumping stopper can do no harm.

The material property of the bearing disc is known to be BC3 (a type of bronze alloy) which is in turn known to be pressure-resistant, abrasion-resistant, corrosion-resistant and of good mechanical property. It is doubtful if the images like rust on the photographs 7, 8, 9 and 15 of Claimants' Exhibit 18 represent rust. Even if they represent rust on the bearing disc, the Tribunal does not consider that the rust falls in the "damage affecting her present class". Some photographs produced suggest that certain apparatus in the steering gear room were rusty. But the Tribunal has noted no evidence of water having entered the steering gear room from the rudder trunk through

the 2<sup>nd</sup> deck. Experience has taught us that some metals including iron and steel tend to get rusted even in the room air, particularly in a marine environment with corrosive spray and sea air. Presence of certain rust in the steering gear room neither prove water having entered there nor prove defect allowing water to enter there.

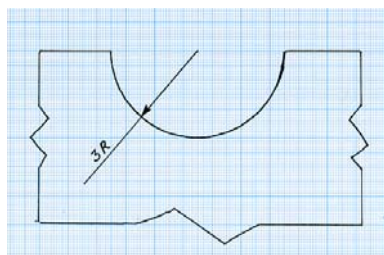
Diagram 14: cross section of the lubrication groove

Because the material property of the bearing disc was BC3 (a type of bronze alloy) and that of the carrier was SC42 (a type of cast steel), if the lubrication of the rubbing surface had been insufficient, most of the wear would have occurred on the upper surface of the bearing disc. Did such wear occur? The bearing disc has a circular lubrication groove and eight radial lubrication grooves crossing the circular groove both engraved on the upper

surface. See Diagram 11 above. As the Claimants' Exhibit 35 indicates, the cross section of the groove takes a form of a semicircle with the radius of 3 *mm*. It follows that the depth of the groove when new was 3 *mm*.

Therefore, if the upper surface of the bearing disc had been evenly worn by 3 *mm* or more in depth, one would no longer have been able to observe grooves on its surface at all. Photograph 9 of Claimants' Exhibit 18 show presence of lubrication grooves as Diagram 11 illustrates. (In contrast, the photograph 6 on page 15 of Mr. A' s website of Claimants' Exhibit 43 shows an example where lubrication grooves have completely vanished .) Diagram 14 above indicates that the width of the groove on the surface of the bearing disc is 6 *mm* at the time of building. Photograph 9 of Claimants' Exhibit 18, taken in October 2006 in China shows that the width of the groove was approximately 1/8-1/7 of the diameter of the recess for set bolt of which the diameter is precisely known to be 40 *mm* by Diagram 11 above. It follows that the width of the groove in October 2006 was approx. 5.0-5.7 *mm*, which in turn suggests that the bearing disc was not worn more than 1.0-1.5 *mm* downward. From a different angle, Diagram 5 indicates that the distance from the surface of the bearing disc to the top of the set bolt in the recess was 5 *mm* when new, which follows if the surface of the bearing disc had worn in excess of 5 *mm*, carrier (of cast steel) would have started metal contact with eight set bolts (of steel) resulting in destructive damage on both surfaces, which, if any, could not have been overlooked by Claimants' surveyor when the rudder system was dismantled in
