## Summary of TOMAC Arbitration

### “STAR ISLAND”

Sale of ship – NIPPONSALE 1993 – Construction of MOA Clause 5 - Whether alleged defect was an ‘average damage affecting her present class’

Tokyo, 3 December 2010

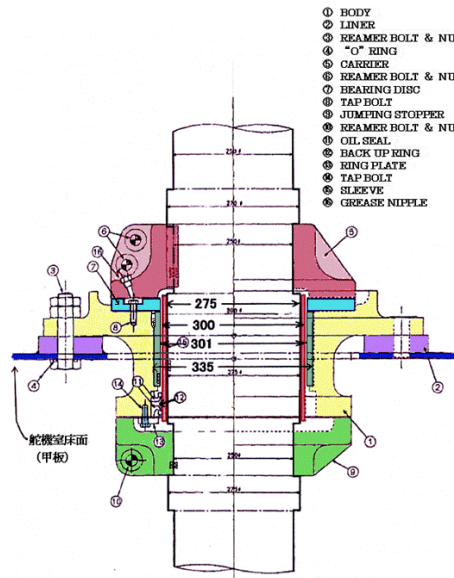
Diagram 5: Rudder Carrier and its components

- iii) “steering gear compartment”: It indicates the steering gear room in the Diagram 4 above.
- iv) “rudder carrier”: they are normally understood to mean the full set of components as indicated in Diagram 3 shown above and Diagram 5 shown hereunder but the same as employed by the above provision of [C3.10.1-3.(1)] of Claimants’ Exhibit 47 are understood by the Tribunal to, in its context, mean rubbing surface between BEARING DISC and CARRIER as indicated by Diagram 5 shown hereunder;

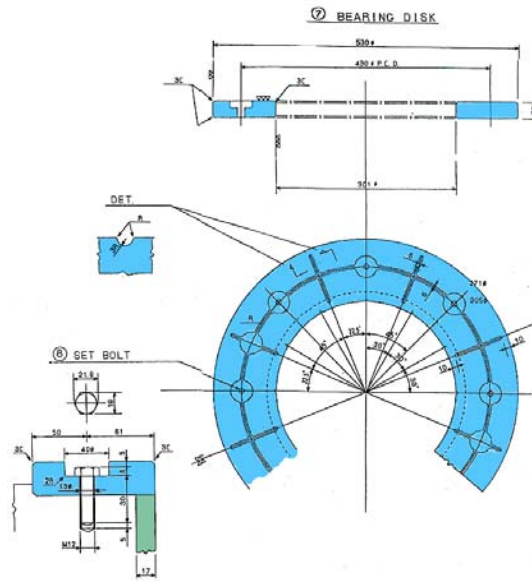
Diagram 11: bearing disc and circular as well as radial lubrication grooves engraved thereon

- xi) *Translation of the arrangement of circular as well as radial lubrication grooves engraved on the upper surface of the horizontal bearing disc (See Diagram 11 hereunder) and axial and circular lubrication grooves engraved on the inner surface of the cylindrical /vertical bush (See Diagram 12 hereunder) is omitted.*
